# Comparison of perch deflection, conductor separation and insulation methods at reducing avian electrocutions at an electricity distribution line in Mongolia

Dixon, A., Batbayar, N., Bold, B., Ganbold, M., Gungaa, A., Purev-Ochir, G. & Tsolmonjav, P. 2025. Comparison of perch deflection, conductor separation and insulation methods at reducing avian electrocutions at an electricity distribution line in Mongolia. – Ornis Hungarica 33(1): 202–212. DOI: 10.2478/orhu-2025-0013

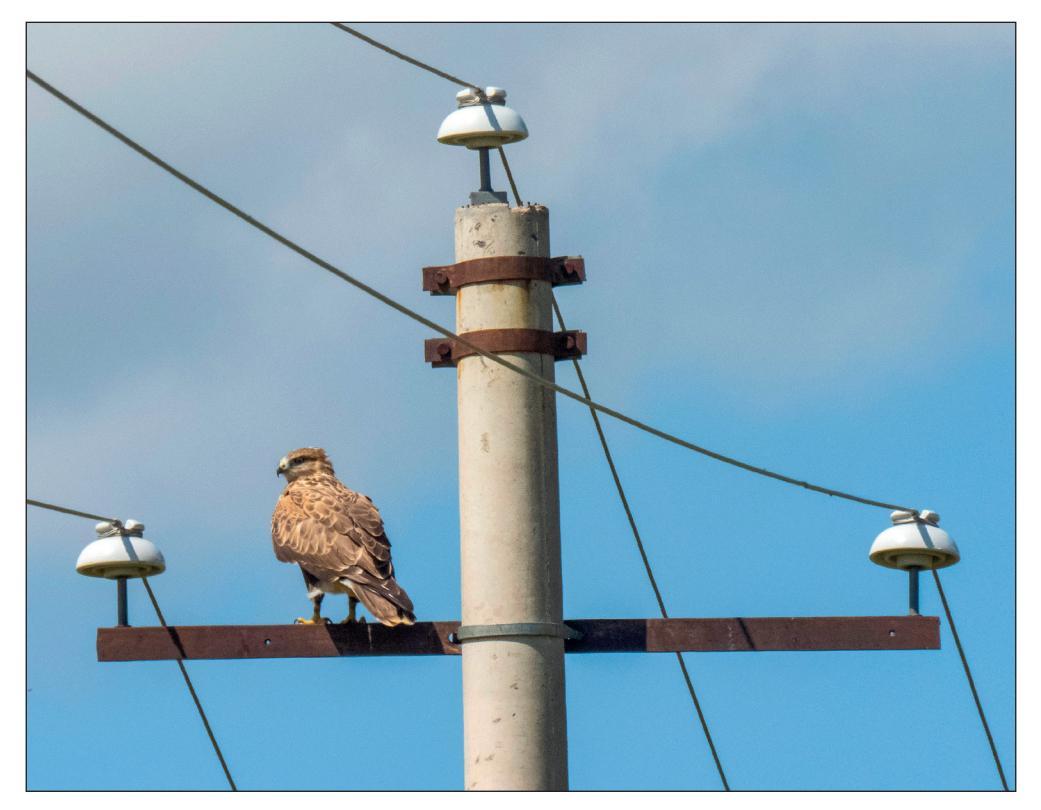
*Figure 1.* Upland Buzzard (*Buteo hemilasius*) perched at an unmitigated standard line pole (control) *1. ábra* Himalájai ölyv (*Buteo hemilasius*) egy szigeteletlen standard oszlopon (kontroll)

We describe a trial of avian electrocution mitigation techniques where the unmitigated line pole configuration comprised a single pin insulator fixed to an upright galvanized steel bracket at the top of the pole (Phase 1; P1), and single pin insulators fixed at the ends of a galvanized steel crossarm (Phases 2, 3; P2/3) (*Figure 1*). At P1, we compared the efficacy of three techniques:

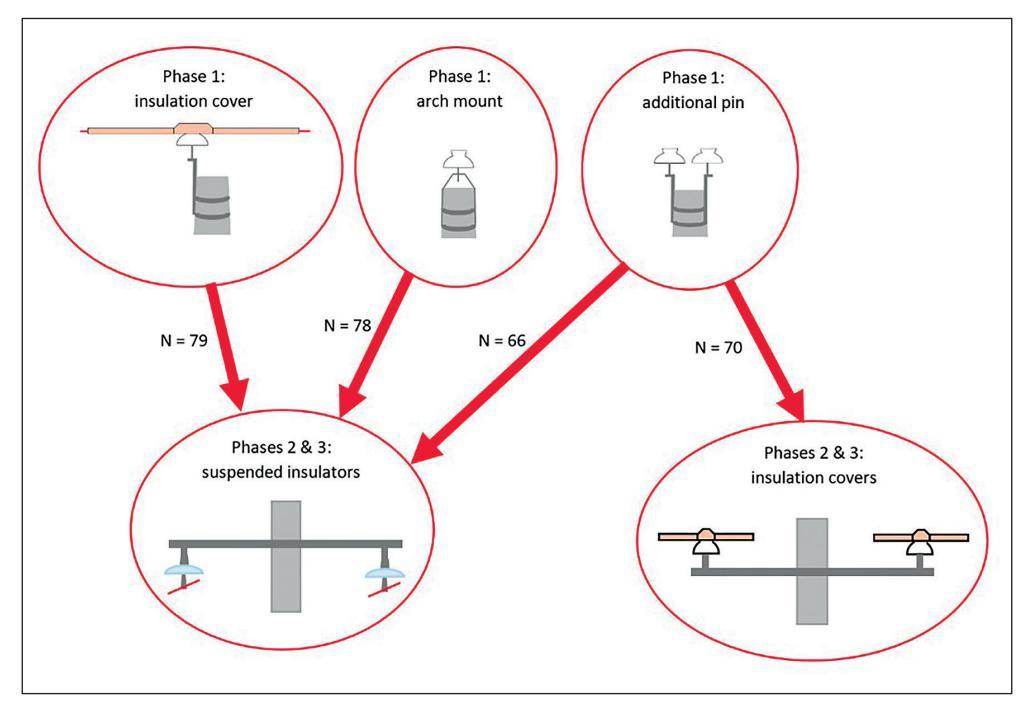
- *Figure 2.* Trial set-up. Efficacy of insulation covers, arch mounts and additional pin-insulator at P1 was compared among poles with suspended insulators at the crossarm. The efficacy of suspended insulators and insulation covers at P2/3 was compared among poles with an additional pin-insulator at the pole top
- 2. ábra Az oszlopok keresztkarján függesztett szigetelőkkel ellátott oszlopok esetében összehasonlítottuk a szigetelőburkolatok, íves tartók és további csúcsszigetelők hatékonyságát az oszlop tetején (P1). Továbbá az oszlop tetején további csúcsszigetelővel rendelkező oszlopok esetében összehasonlítottuk a függesztett szigetelők és a szigetelőburkolatok hatékonyságát a keresztkarokon (P2/3)

(i) insulation of the conductor cable, and physical deflection of birds from dangerous perching sites by (ii) adding an additional pin-insulator and (iii) changing the pin-insulator mount from an upright bracket to an arch-shaped mount, while at P2/3, we compared the efficacy of (i) insulation of the conductor cable, and the physical separation of perching sites from conductor cables by using (ii) suspended insulators at crossarms. For the experimental trial, we divided the line into 24 sections of line poles between anchor poles, excluding 72 and 42 poles at each end of the line. We allocated lines section to five treatment groups, which were determined by a pre-existing configuration based on random allocation for a previous trial (see Dixon *et al.* 2019). On 4 and 5 October 2018, we added additional pin insulators at P1 to 131 poles and suspended insulators at P2/3 to 223 poles in the following five treatment arrangements (*Figure 2*): (i) P1 Additional Pin Insulator in combination with P2/3 Suspended Insulators in combination with P2/3 Insulated Conductor (P1Add + P2/3Ins; 70 poles/4 sections), (iii) P1 Insulator in combination with P2/3 Suspended Insulators (P1Arch Type Mount in combination with P2/3 Suspended Insulators

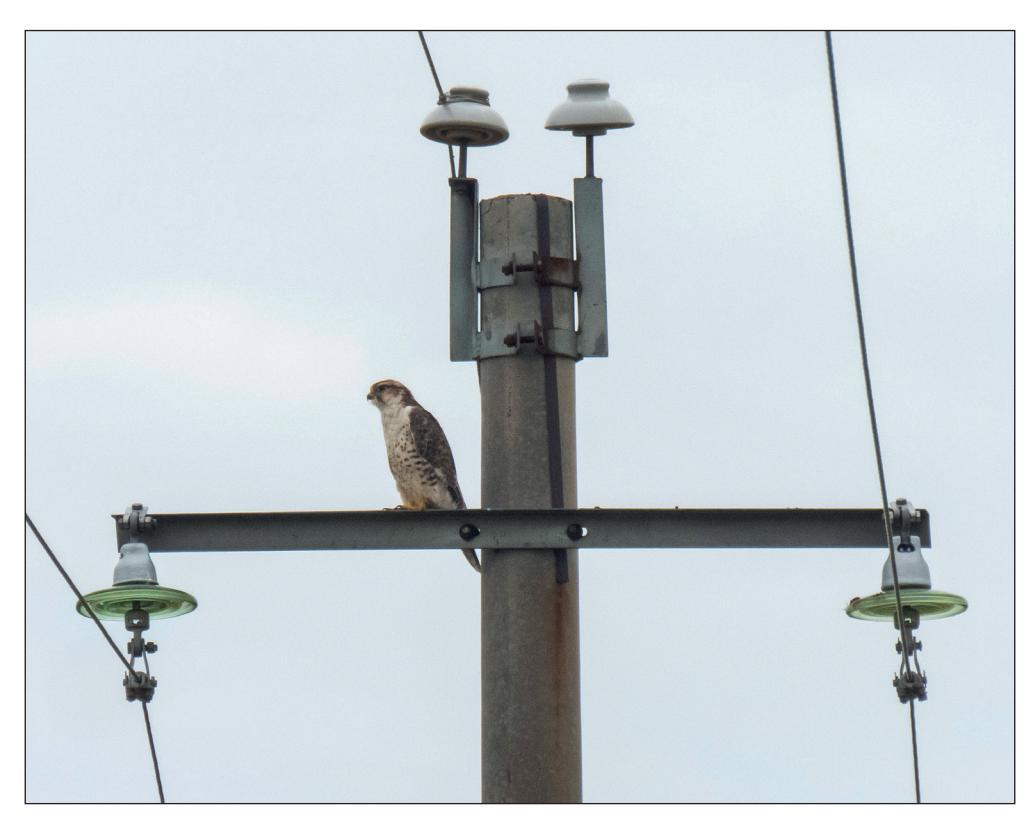
- *Figure 3.* Saker Falcon perched at experimental pole with an additional unconnected pin-insulator fitted to P1 to deflect birds from dangerous perch sites at the concrete pole top, and suspended insulators to separate conductors at P2/3 from perch sites on crossarm
- 3. ábra A kerecsensólyom egy kísérleti oszlopon ül, amelynek tetején (P1) egy további, nem csatlakoztatott csúcsszigetelőt helyeztek el, hogy elriassza a madarakat a veszélyes beülőhelyektől a betonoszlop tetején. Emellett a keresztkarokon (P2/3) függesztett szigetelők választják el a vezetékeket az esetleges beülőhelyektől, csökkentve ezzel a madarak áramütésének kockázatát

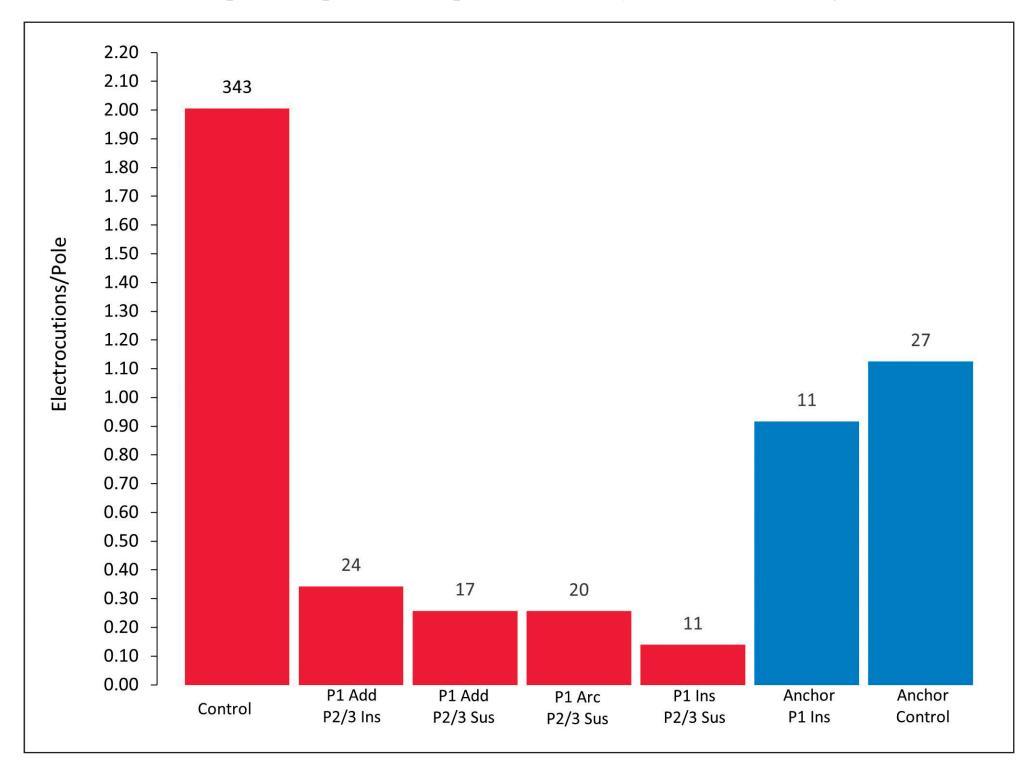
*Figure 4.* Avian electrocutions per pole in each treatment group of line/tangent poles (red) and anchor/dead-end poles (blue). Values represent the number of carcasses found for each treatment group

4. ábra A madarak áramütéses eseteinek száma oszloponként az egyes kísérleti csoportokban: standard állású/tangens oszlopok (piros) és feszítő/végoszlopok (kék). Az értékek az egyes kezelési csoportokban talált tetemek számát jelzik on the crossarm, we found no significant difference in efficacy between conductor insulation and suspended insulators *(Table 1)*. Additionally, using treatment groups that all had suspended insulators on the crossarms to compare the efficacy of different configurations at P1 on the pole

At standard line poles, all treatments significantly reduced electrocutions in comparison to the control *(Table 1, Figure 4)*. Using treatment groups that all had additional pin insulators at the top of the pole to compare the efficacy of different configurations at P2/3

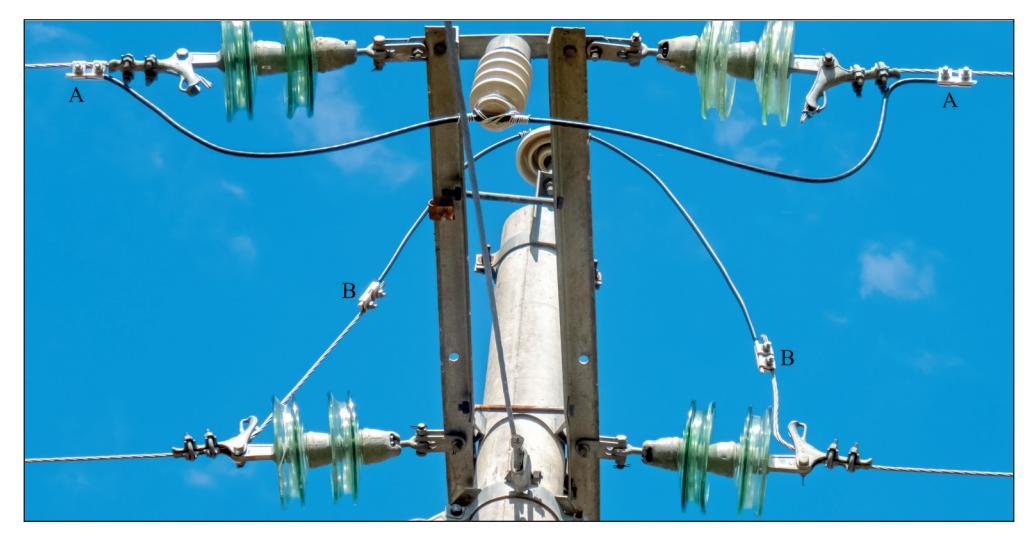
- *Figure 5.* Insulated jumper wires connected to conductors at anchor pole. A: shows correct fitting at P2/3 with cable connection in front of the dead-end clamp. B: shows incorrect fitting at P1 with cable connection on jumper wire after the dead-clamp, leaving exposed conductors above perch sites on the crossarm
- 5. ábra Szigetelt összekötő vezetékek csatlakoztatása feszítőoszlopon lévő vezetékekhez. A: helyes csatlakoztatás a P2/3 pontokon, ahol a kábelkapcsolat a végzáró bilincs előtt van. B: helytelen csatlakoztatás a P1 ponton, ahol a kábelkapcsolat a végzáró bilincs után van az összekötő vezetéken, így a keresztkaron lévő ülőhelyek felett szabadon maradnak a vezetékek

At anchor poles, we found no effect of replacing uninsulated jumper wires at phase 1 with insulated cable *(Table 2)*. However, this anomalous result was probably due to incorrect fitting of the insulated jumper cables where the engineers had left an exposed section of uninsulated conductor cable at either end of the cable connecting joints *(Figure 5)*, which posed an electrocution risk for birds perching nearby.

Ongoing electrocution risk can be the result of incorrectly fitted mitigation, described by Dwyer *et al.* (2017) as 'application' errors in retrofitting. Our attempt to mitigate jumper wires at the central phase of anchor poles was unsuccessful due to the insulated jumper cable being too short, leaving a long length of uncovered jumper wire and an uninsulated cable connecter at each end. It is likely this occurred when engineers precut the insulated jumper wires too short at a fixed length prior to installation, and they did not fully appreciate the objective of ensuring that the whole length of the jumper wire from the dead-end clamp was insulated. Consequently, we were not able to examine the efficacy of using fully insulated jumper cables at reducing electrocution risk.
