Journal of Raptor Research

Journal of Raptor Research 59(2):jrr2476 doi: 10.3356/jrr2476 © 2025 The Raptor Research Foundation, Inc.

Electrocution of Steppe Eagles and Golden Eagles in Mongolia

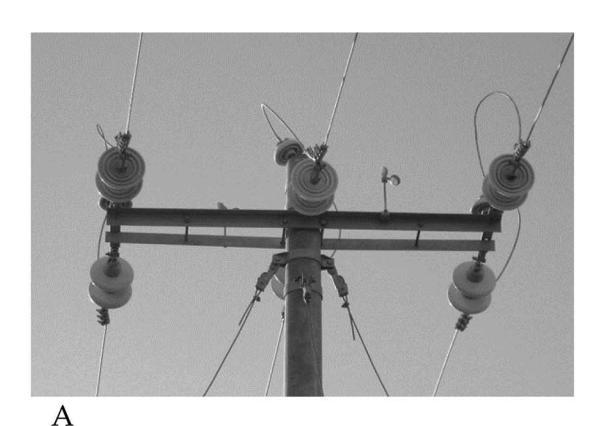
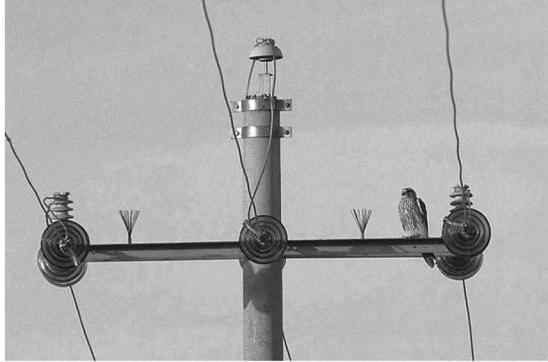
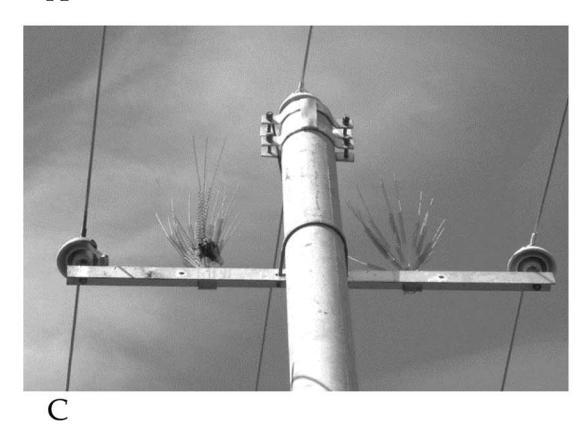
Figure 1. (A) Anchor pole with damaged mirror perch deterrents, (B) short wire brush perch deflectors and perched Saker Falcon (*Falco cherrug*), (C) long wire brush perch deflector, with head of Steppe Eagle.

Avian electrocution on distribution power lines is a major cause of mortality for raptors in central Asia (Dixon et al. 2013, Dwyer et al. 2022), India (Harness et al. 2013), Africa (Boshoff et al. 2011, Angelov et al. 2012), Europe (Prinsen et al. 2011) and North America (Avian Power Line Interaction Committee [APLIC] 2006). In Mongolia, many 15-kV distribution lines are particularly dangerous for birds of prey, especially those lines in open steppe habitats with a high density of rodent prey nearby (Harness et al. 2008, Dixon et al. 2017). Avian electrocution in Mongolia is primarily associated with infrastructure consisting of grounded steel-reinforced concrete poles with steel crossarms and brackets supporting upright pin insulators (Fig. 1; Harness et al 2008).

The poles at these lines were either unmitigated (not modified to reduce avian electrocution risk) or were mitigated with one of two main types of mitigation: (1) grounded steel perch deflectors, either wire brushes or spikes affixed centrally on the crossarm either side of the pole, or (2) rotating mirror perch deterrents that were similarly affixed midway between the pole and the upright pin insulator of the crossarm (Fig. 1).

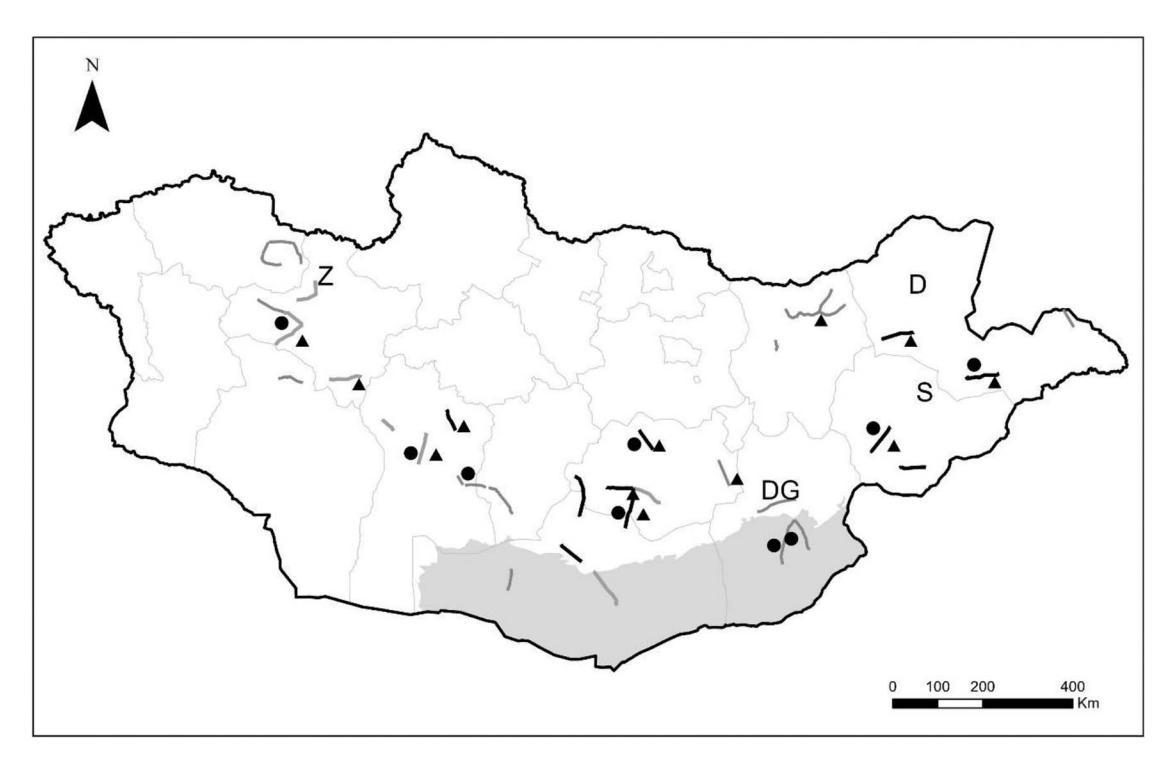
Figure 2. Map showing the distribution of surveyed 15-kV power lines in Mongolia. Black lines denote power lines that were surveyed in 2013, 2014, and 2015; and gray lines denote power lines that were surveyed daily from August 2013 to August 2014. More recent electrocutions of Steppe Eagles (black triangles) and Golden Eagles (black dots) were discovered during surveys from 2018 through 2022. Initials refers to provinces mentioned in the text: Z = Zavkhan, DG = Dornogovi, S = Sukhbaatar, and D = Dornod. The shaded area represents the portion of the Gobi Desert that occurs in southern Mongolia; all other lines were located in the central steppe zone.

We report on three distinct power line studies in Mongolia (Fig. 2): (1) single-visit surveys of widely dispersed distribution lines from 2013 through 2015 to assess the extent of eagle electrocutions and the range of mitigation methods employed, (2) daily monitoring of a single line with experimental mitigation to elucidate temporal patterns of electrocution and specific danger points on power poles

no significant difference in eagle electrocution rates per 1000 poles between lines with and without mitigation (t = 1.266, df = 13, P = 0.23). Both species were mainly killed at power lines in the central steppe zone of Mongolia, from Zavkhan in the west to Dornod province in the east. Only Golden Eagles were electrocuted in the Gobi Desert in Dornogovi province (Fig. 2).

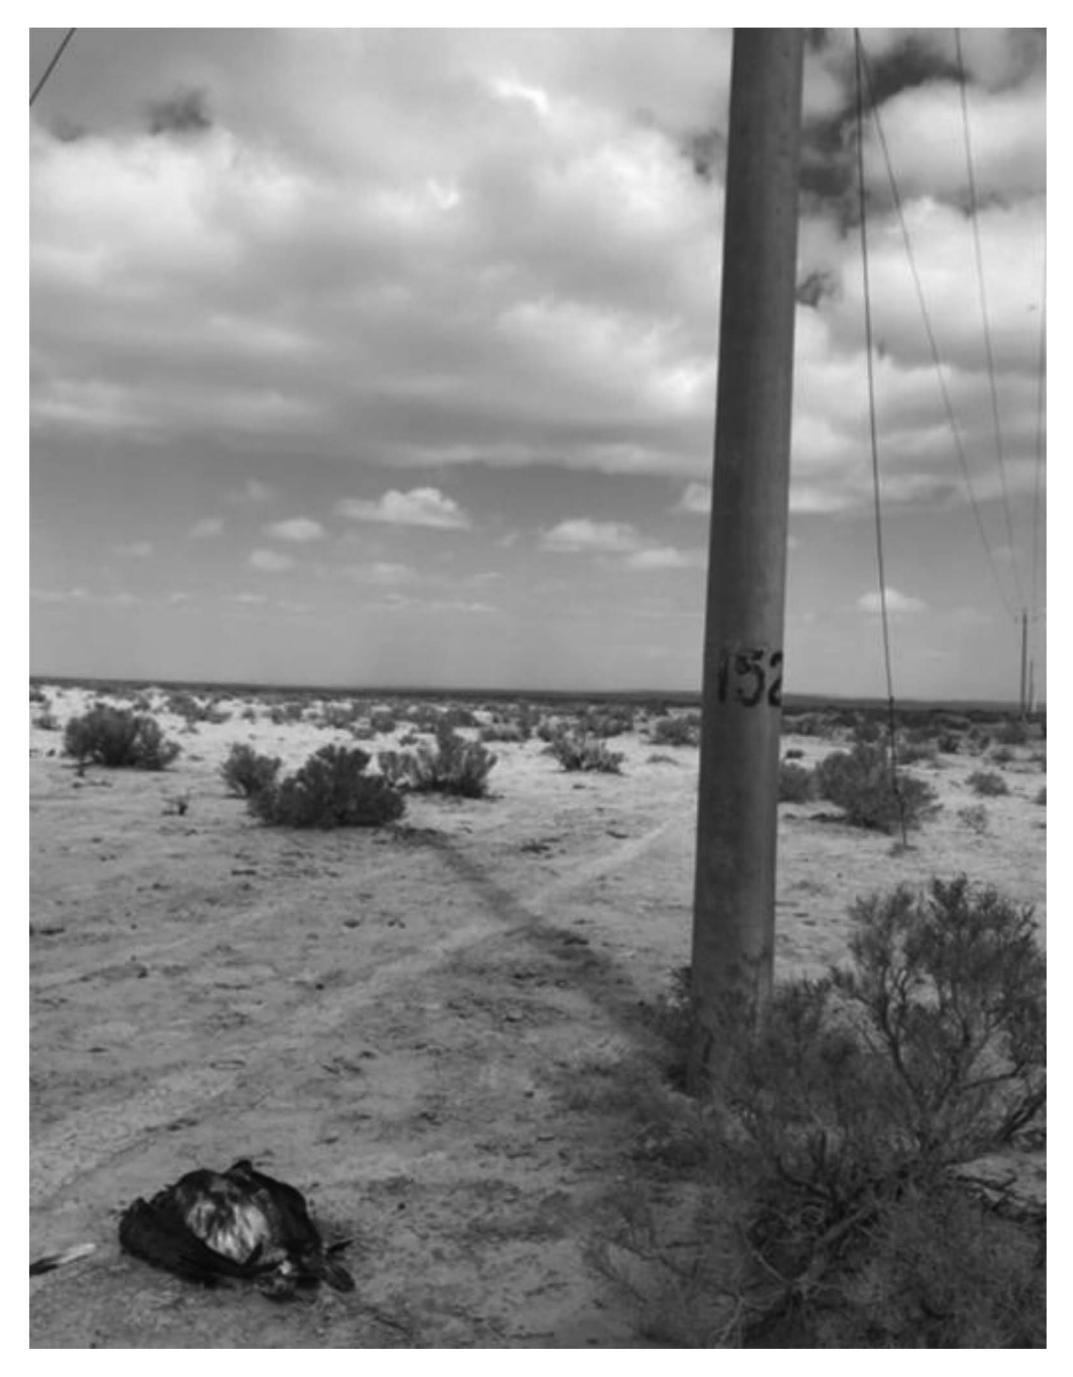
Figure 3. An electrocuted Golden Eagle, one of 22 found during a single visit survey at a power line in Dornogovi province on 25–26 May 2021.

The exceptionally high number of eagle fatalities over a short period at one line during late winter in 2021 suggests specific factors contributed to this mass electrocution event. The semidesert scrub habitat along this line was particularly suitable for Tolai hares (*Lepus tolai*), a potential prey species for Golden Eagles in winter. It is possible that high prey densities resulted in large numbers of eagles using the line for hunting over a limited period during spring migration in 2021. The approximately north-south direction of the line would intercept Golden Eagles migrating toward the Gobi-Altai mountains from the eastern grasslands of Mongolia and China, causing all birds transiting the area to encounter this line. Golden Eagles do not migrate in flocks, so it is unlikely that significant numbers were simultaneously forced to seek perching sites on power poles during harsh weather conditions.
